# San Fernando, California, Earthquake of February 9, 1971

U.S. DEPARTMENT OF COMMERCE  
National Oceanic and Atmospheric Administration

*Part B. Buildings continued; Soils and Foundations*

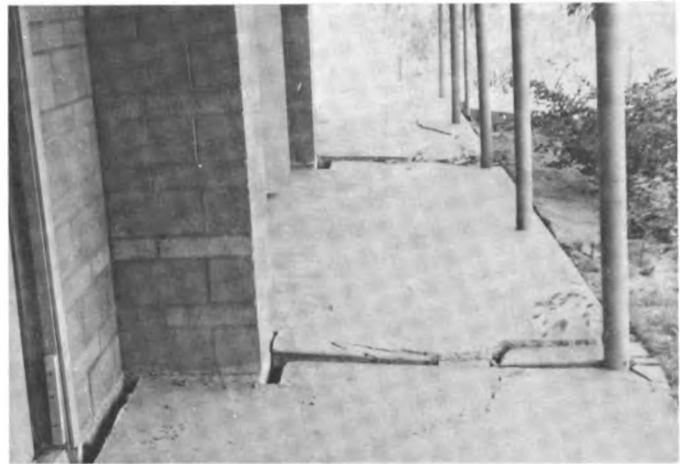
Figure 9.—Camp Karl Holton Juvenile Facilities. Recreation building. Sidewalk and ground rupture along west wall.

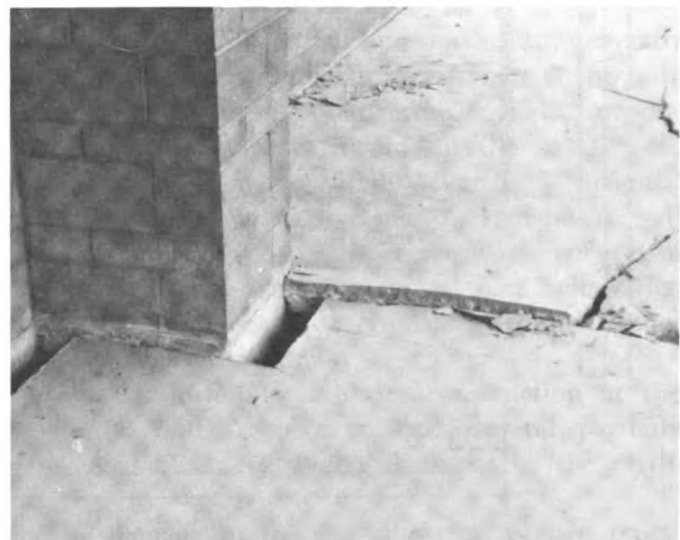
Figure 10.—Camp Karl Holton Juvenile Facilities. Recreation building. Sidewalk rupture at west wall.

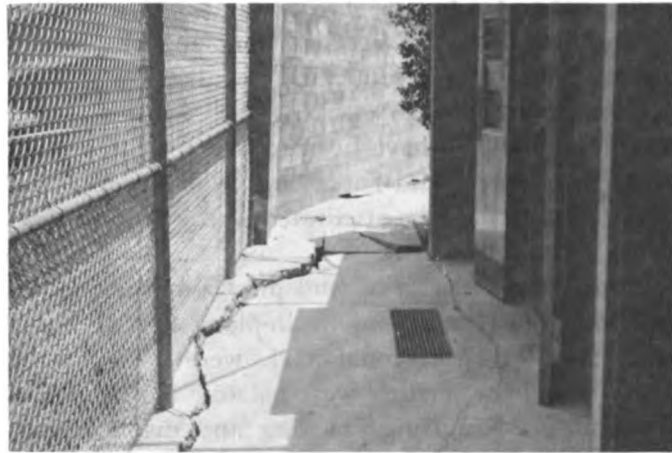
Ground movement and cracking were heavy at this location. Exterior sidewalks at the east end were cracked and dislocated (fig. 15). Ground fissures several inches wide occurred in the dirt driveway just

Figure 15.—Camp Karl Holton Juvenile Facilities. Dormitory building. Sidewalk ruptures at east end of building.

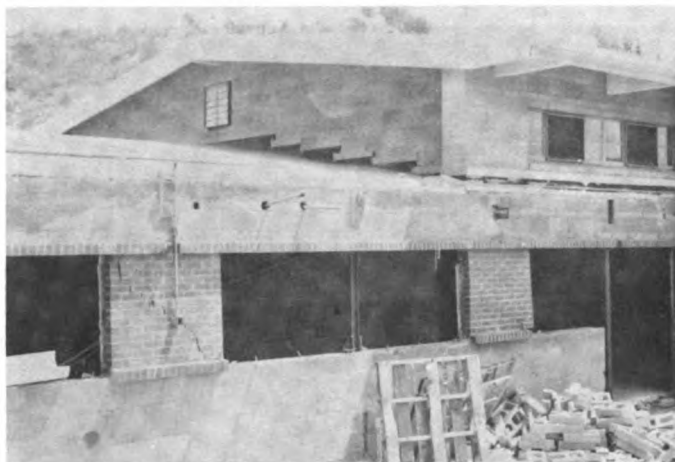
A new addition was under construction at the south-side wall at the west end. Several partially completed block walls were damaged by the earthquake.

Figure 16.—Camp Karl Holton Juvenile Facilities. Dormitory building, south wall, west end. Note building material on ground from partially completed additions.

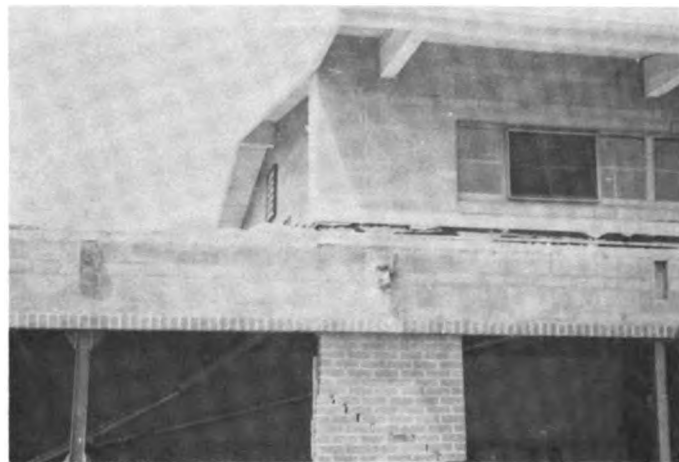
Figure 17.—Camp Karl Holton Juvenile Facilities. Dormitory building. Cracked wall piers in lower and upper piers, south wall.

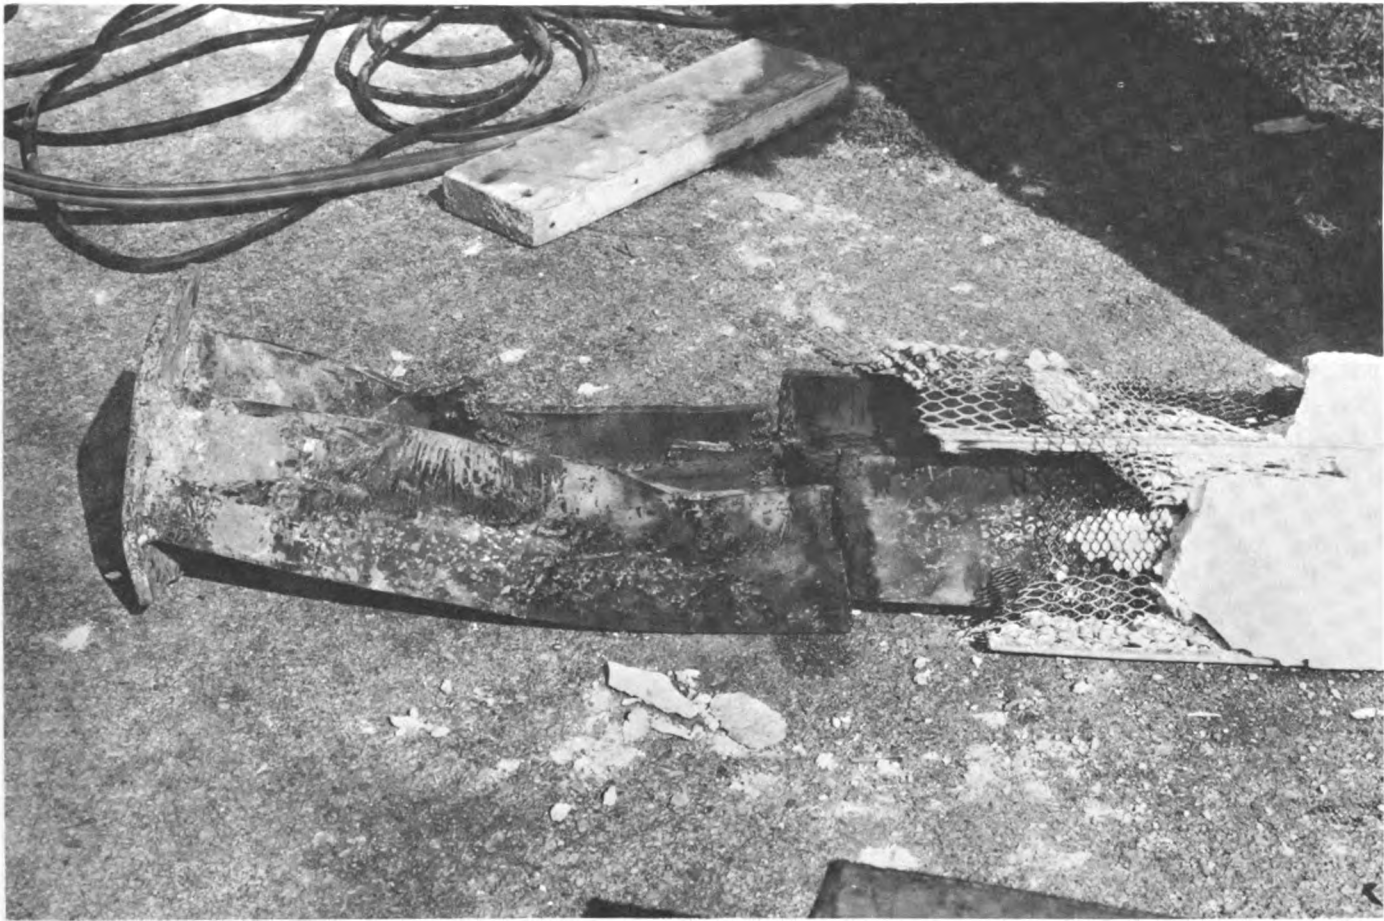
Figure 6.—Foothill Medical Center. Base of 5WF16 column on line 3 after being removed from structure. Gusset plate is up for reference. Los Angeles City Department of Building and Safety, John Shadle, photographer.

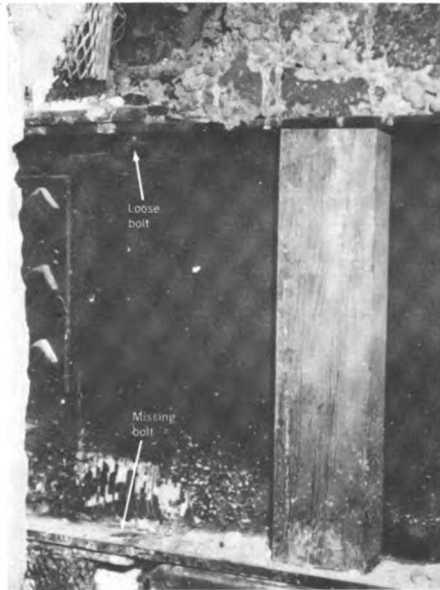
Figure 7.—Foothill Medical Center. Second-floor beam on line 3 with 5WF16 column and brace connections. Note missing bolt at lower flange and loose bolt at top flange. Loring A. Wyllie, Jr. photograph.

It would appear that the failure in the bracing on line 3 was initiated by yielding and slight initial deflection of the 5WF16 column near its base where the brace connection was eccentric. Once a small deflection of the columns took place, it caused virtually all the load to be transferred to the other diagonal, which resulted in the shearing of the bolts to the

Repairs to the structure consisted of replacing the sheared bolts and installing an oversized gusset plate at the first floor to partially compensate for the eccentricity of the one diagonal on line 3. Figure 12 shows this connection as repaired and can be compared with figure 5. A new 5WF column was installed on line 3 to replace the badly distorted columns. Angles were installed to reanchor the exterior screen support columns as shown in figure 10. Plaster, ceiling, and stairway repairs also were required.

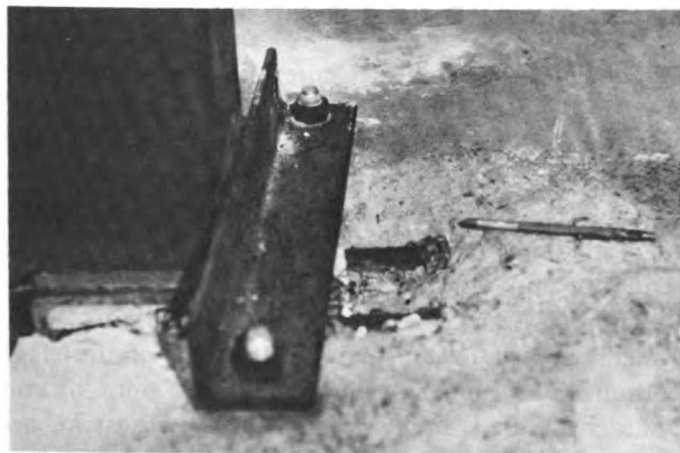
Figure 10.—Foothill Medical Center. Base of typical 6- by 10-inch structural tube column for exterior sun shade. Note spalled concrete and horizontal anchor bolts. Angle added after earthquake as a repair. Paul F. Fratessa photograph.

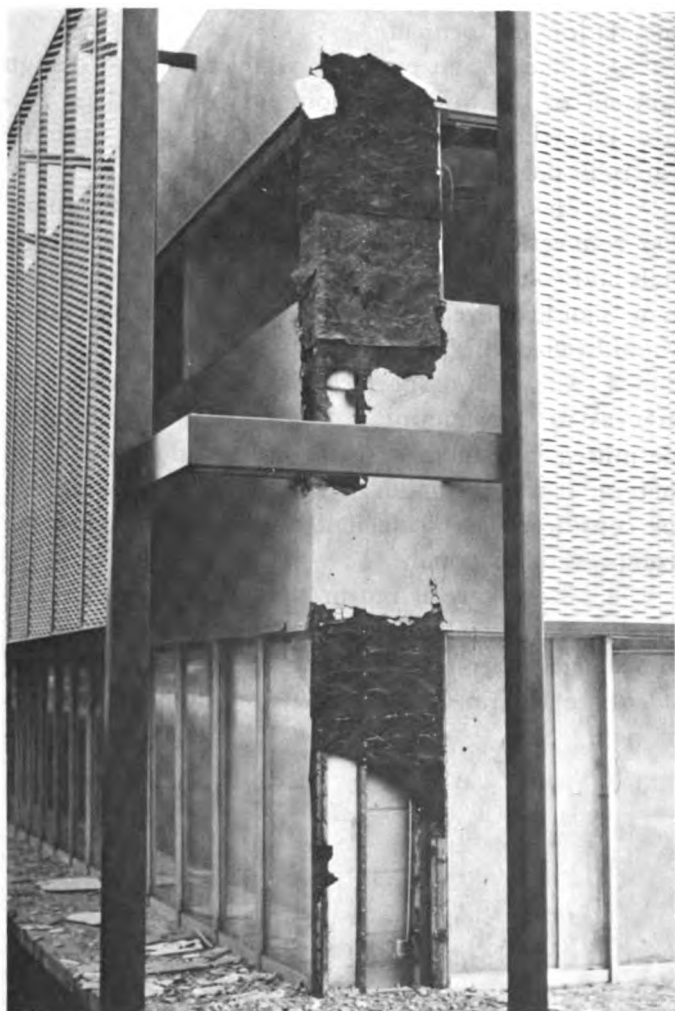
Figure 11.—Foothill Medical Center. Exterior of building at north corner showing plaster and glass damage. Loring A. Wyllie, Jr. photograph.

bottom flange of the second-floor beam. After the failure of these bolts, only one diagonal was available to work in both tension and compression and to resist the entire lateral load. This diagonal was connected to the 10WF29 column at the second floor, which in turn was welded to the longitudinal 14WF34 beam, thereby providing a connection even after the two bolts to the bottom flange of the 16B31 sheared (fig. 8). The sizable axial forces in the diagonal, coupled with the fabricated eccentricity at the 5WF16 column, caused the severe distortion of that column. It is estimated that a ground acceleration of approximately 7 percent of gravity would be sufficient to cause the first failure of the bracing system as fabricated and built, as compared to a code-required base shear of 13.3 percent of gravity. It appears that the first-story partitions tried to assist the failed bracing system. Forces apparently were transferred through the 2- by 4-inch struts to the corridor partitions to the capacity of the toenailing. Large transverse movements of the building could be verified by several interior columns that punched through the corridor partition, the severe cracking of the southern stairway and the extensive glass breakage at the north end, and the rotation of the exterior tube columns supporting the sun shade. This damage was most evident at the north end of the building where the bracing failed and permitted larger movements.

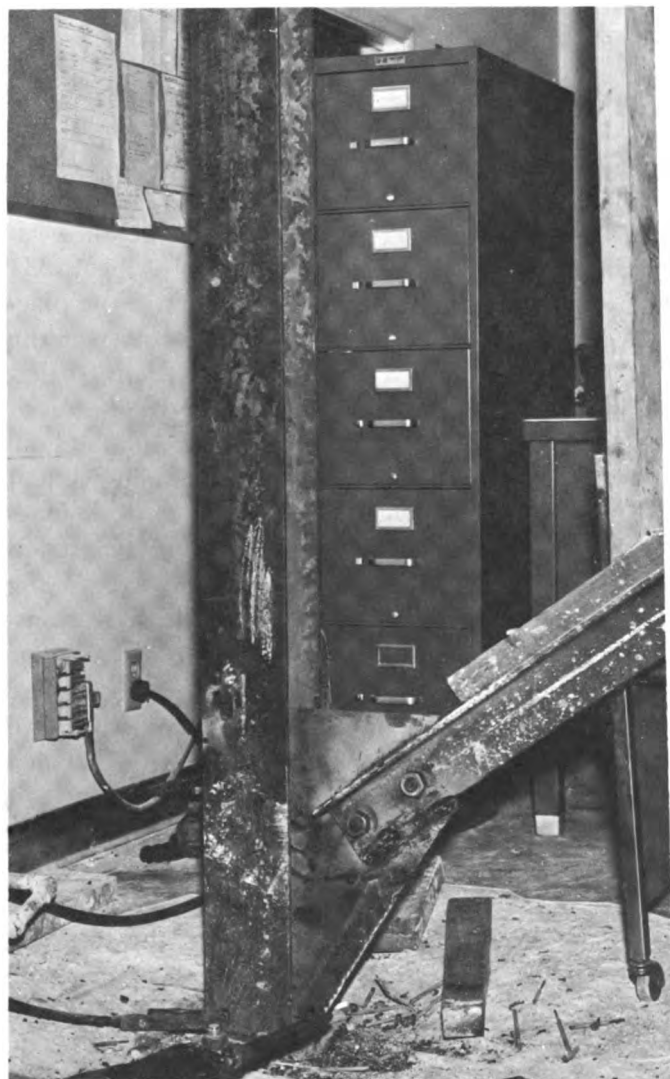
*Figure 12.—Foothill Medical Center. Base of 5WF16 column on line 3 as repaired with oversized gusset plate. Los Angeles City Department of Building and Safety, John Shadle, photographer.*

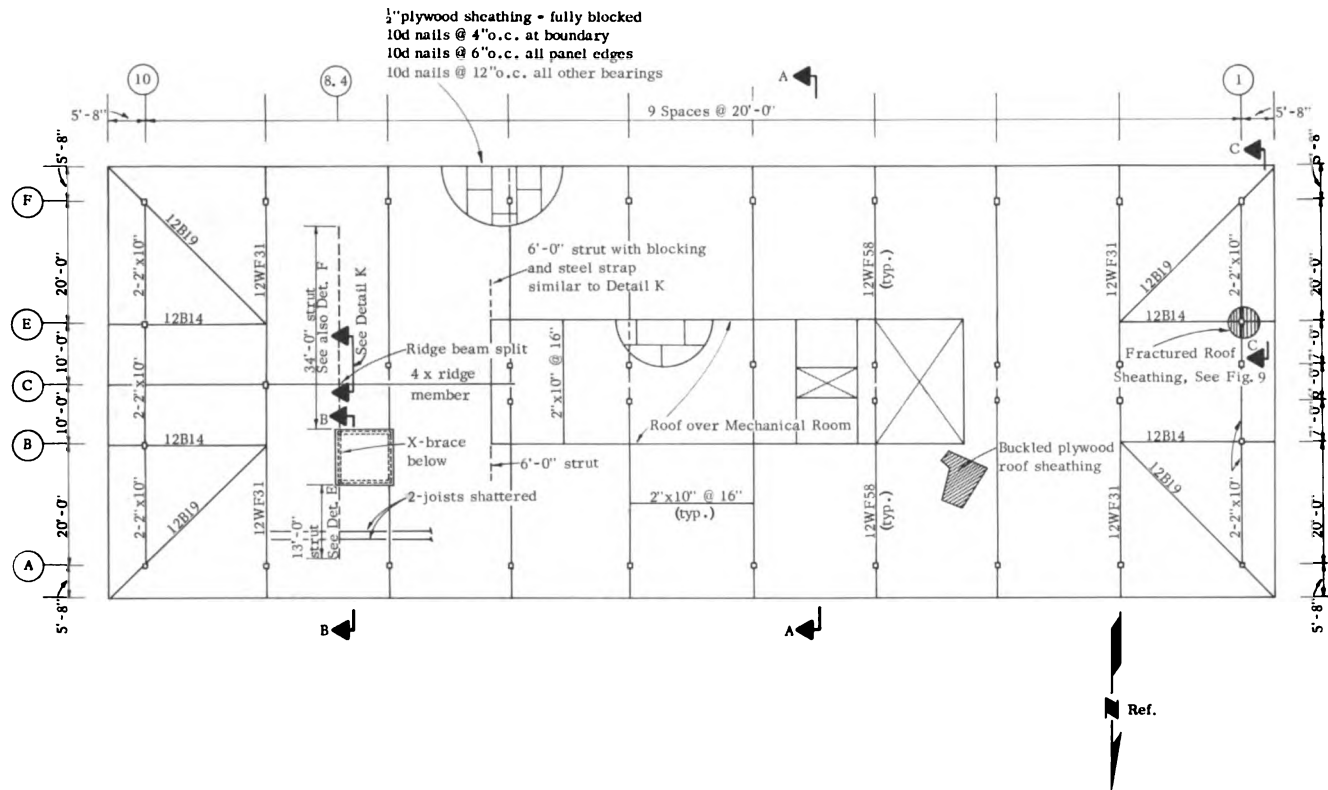
Figure 3.—Pacoima Lutheran Medical Center. Roof framing plan.

As shown on the roof framing plan, figure 3, the plywood roof sheathing buckled near the northwest corner of the mechanical penthouse. As noted pre-

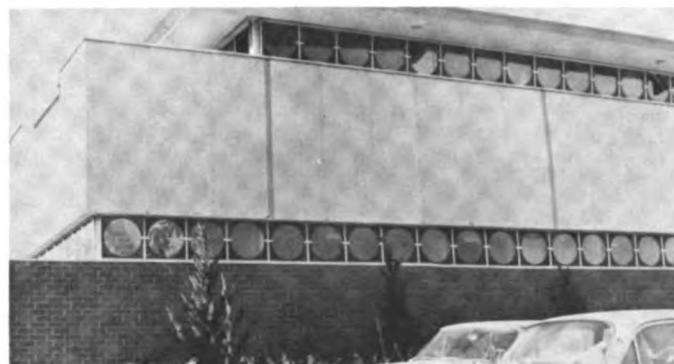
An initial examination of the exterior of the building led to the misleading conclusion that there was little or no structural damage. Figure 5, a photograph taken immediately after the earthquake, shows a few broken windows, but little else in the way of damage. It was reported that office equipment, desks, and filing cabinets moved across the second floor and, in some cases, tipped over. Some nonstructural damage was reported, such as buckling of the second floor T-bar ceiling, partition damage at the second floor, and spalling of the first-floor brick sills.

Figure 5.—Pacoima Lutheran Medical Center. Southwest corner, just after earthquake. Note two broken panes of glass at the second floor. Ralph Goers photograph.

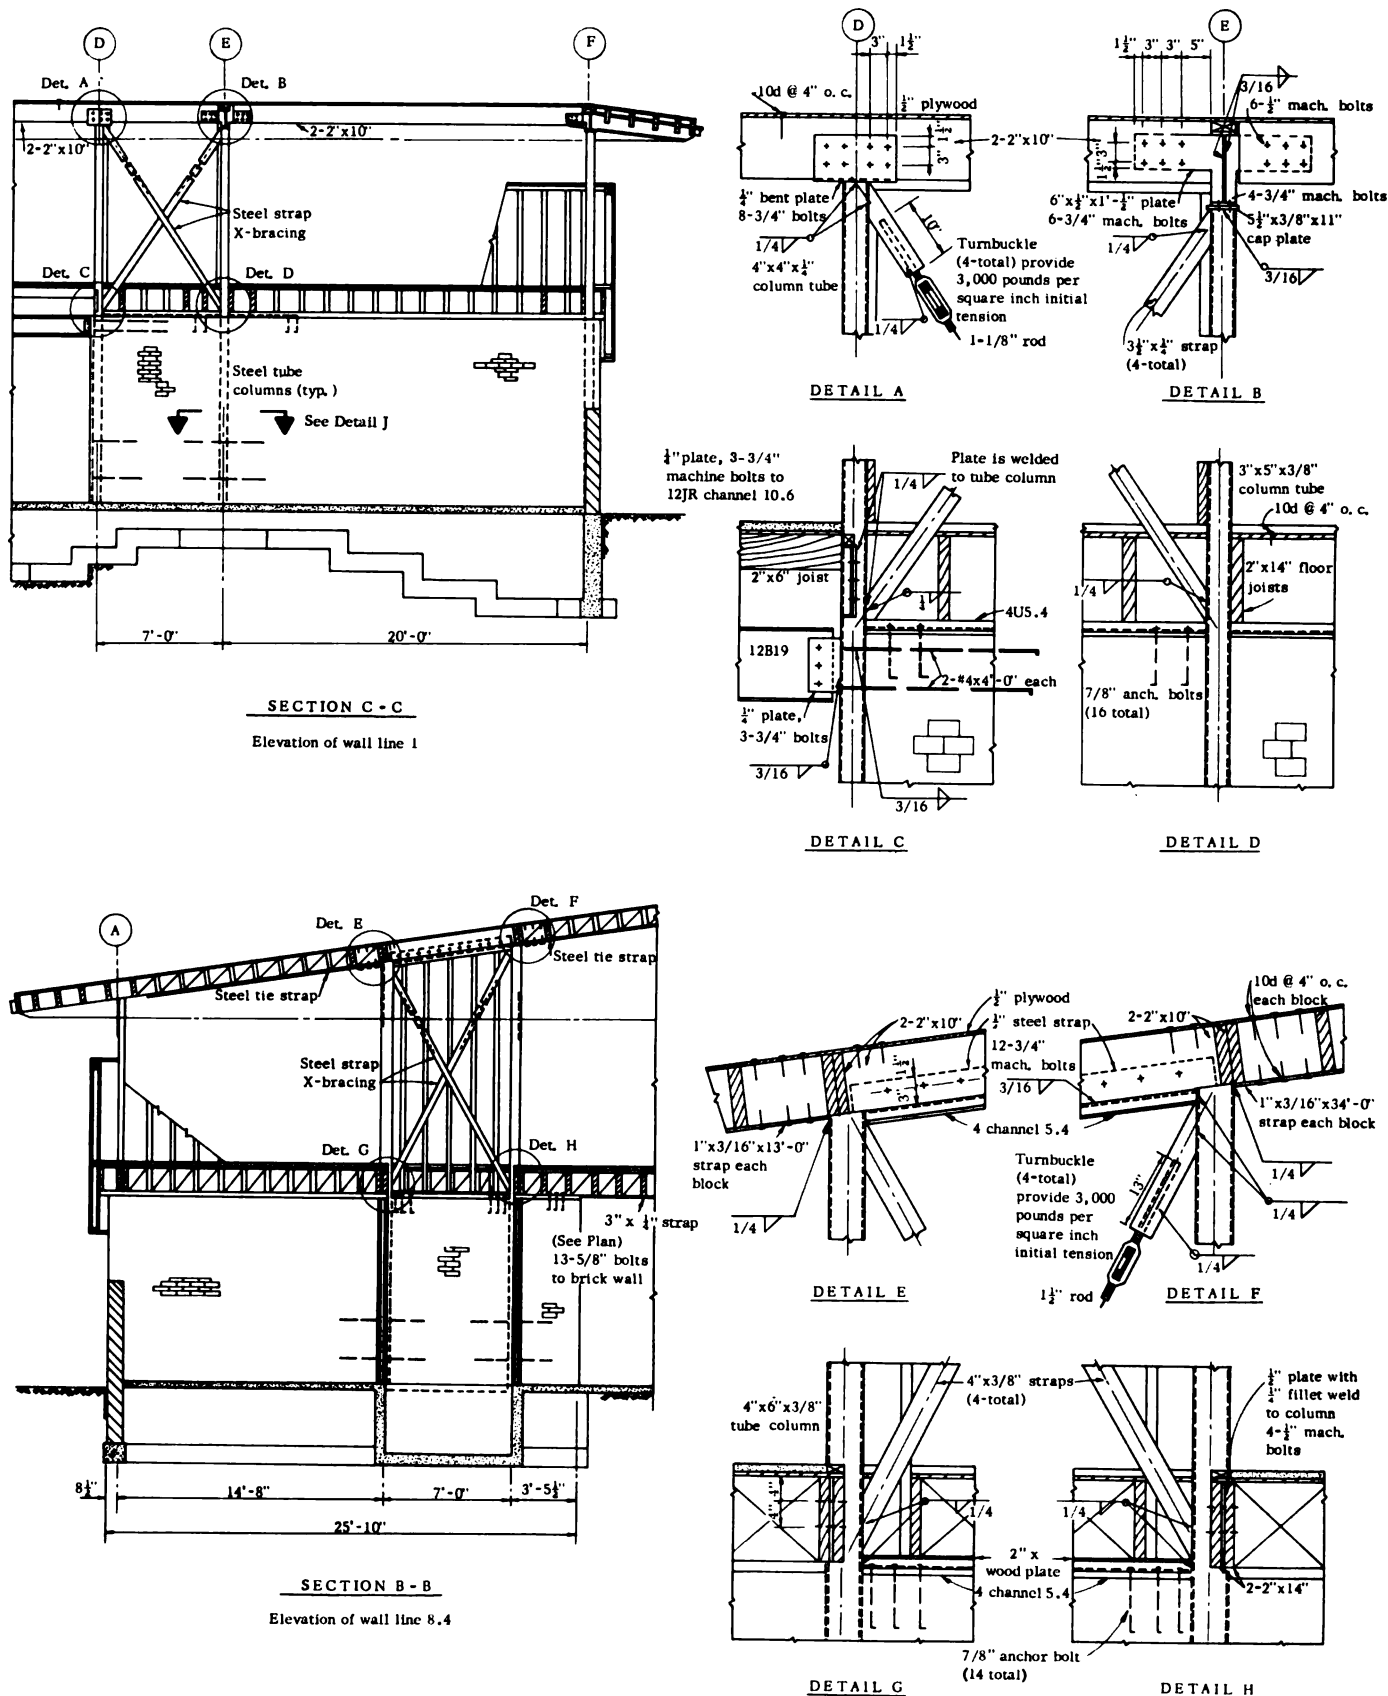
Figure 6.—Pacoima Lutheran Medical Center. Elevation of wall lines 1 and 8.4.

Although the building survived the earthquake with a relatively moderate amount of total damage, there was significant structural damage in several key areas. Probably the most significant occurred at the north-south shear walls on lines 1 and 8.4 (fig. 6).

At line 1, the double 2- by 10-inch roof collectors (fig. 6, details A and B) failed at the connections to the steel X-bracing system at lines E and D (fig. 7). The tube column at line E was bowed in the direc-

At line 8.4, several failures occurred in the collector system used to transfer the forces to the steel X-bracing. This system is as shown in figure 6, details E through H. The 1-inch by  $\frac{3}{16}$ -inch by 34-foot strap noted in detail F extends to the ridge and beyond, as shown on the roof plan and figure 6, detail K. The 4- by 10-inch wood ridge member was split

badly at the strap connection. There was an area on the north side of the X-brace where blocking rotated in a vertical plane, adjacent joists shattered, and the strap buckled. The 1-inch by 3/16-inch by 13-foot steel strap shown in detail E failed at the connection to the column, probably at the fillet weld. The X-bracing itself was not damaged. At the strap connection to the brick wall under the second floor (fig. 6, section B-B), nails from the strap to the blocking were popped out for a distance of several feet.

On line 1 (fig. 6), the X-bracing in the second story was replaced with a 15-foot-long grouted brick panel and a structural steel collector system at the roof. The cracked area in the first story was repaired by removing and replacing a 2-foot-wide band centered on the crack.

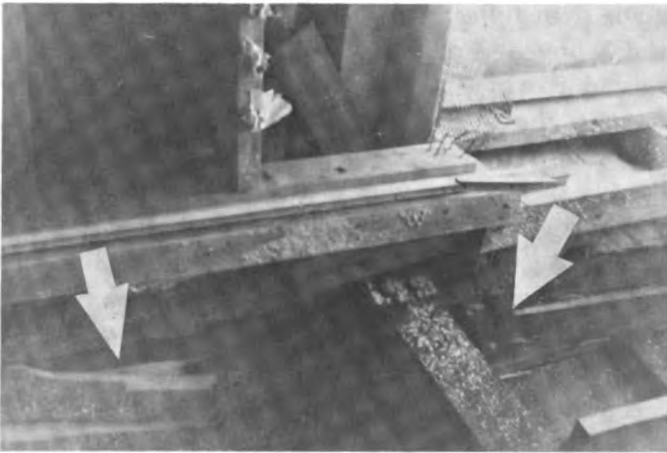
Figure 7.—Pacoima Lutheran Medical Center. Connection of steel bracing (line 1) to timber ties at roof on line E. Arrows point to splitting of 2- by 10-inch ties on each side of column. Ralph Goers photograph.

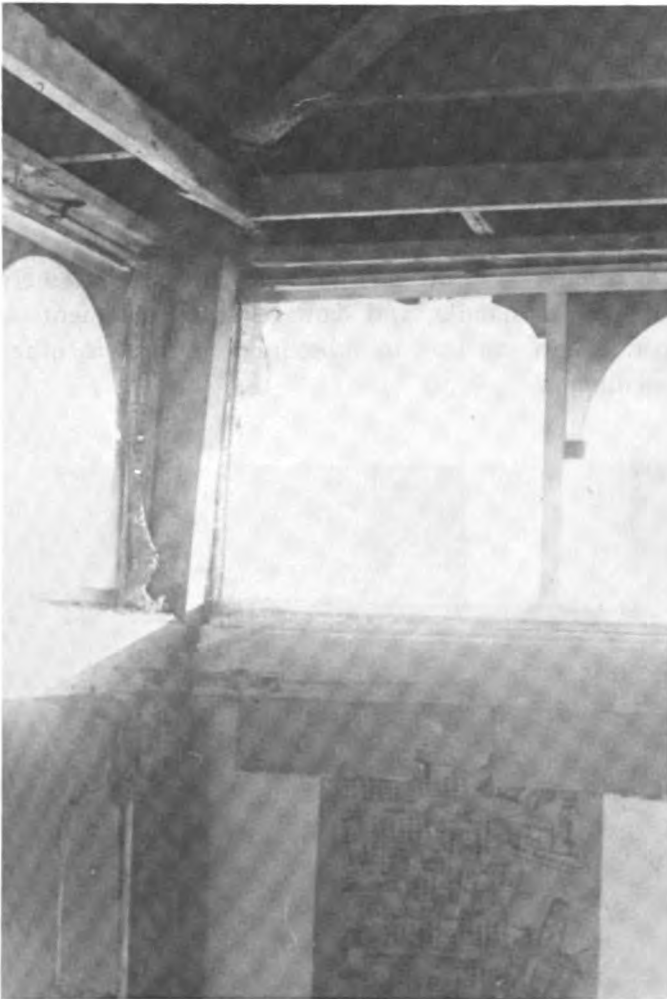
tion parallel to the wall. The corner column at line F also yielded in bending, as shown in figure 8. It is evident that these columns acted as cantilevers above the window sill, probably after the buckling failure of the steel plate X-braces. In figure 6, detail B, there is considerable eccentricity involved in the transfer of shear from the roof diaphragm into the X-bracing system. The resulting moment must be transferred through the straps and bolts to the double 2- by 10-inch wood members. It is evident that this contributed to the shattering of the wood members, which was probably followed by the buckling on the X-braces and the bending yield of the columns. Plywood roof sheathing above this connection buckled, causing roof failure (fig. 9). Below the second floor, the grouted brick wall cracked (fig. 10) where the tube column at line E was embedded in the wall (fig. 4, detail J).

Figure 8.—Pacoima Lutheran Medical Center. Column F-1, second floor, looking south. Ralph Goers photograph.

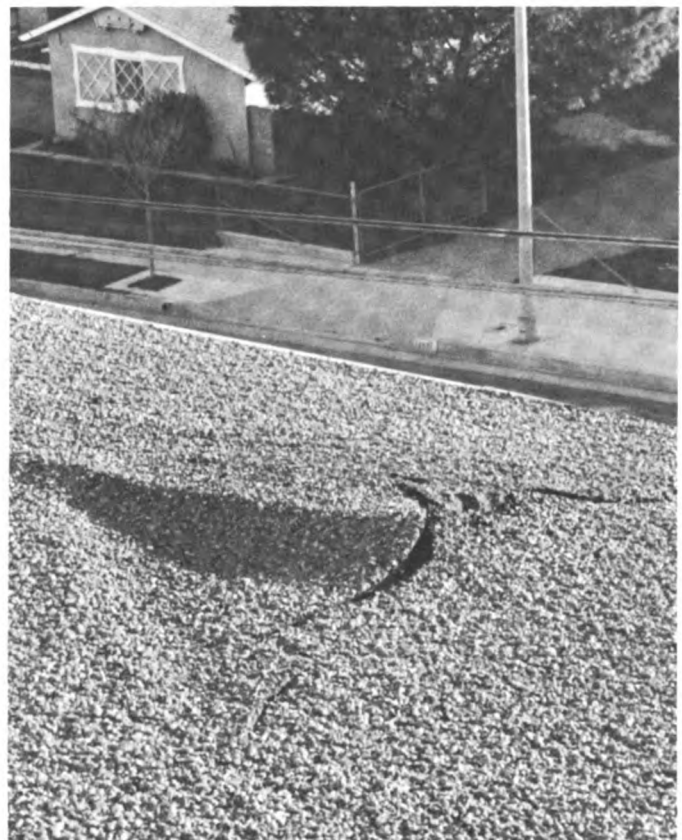
Figure 9.—Pacoima Lutheran Medical Center. Break in roofing at plywood failure at southwest corner immediately above detail B (fig. 6). Ralph Goers photograph.

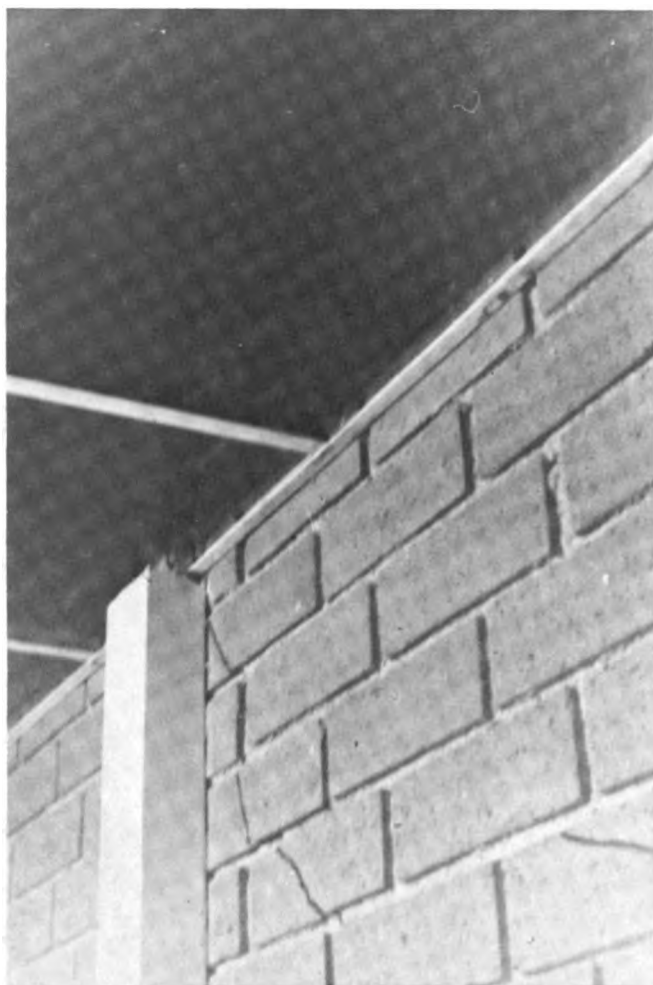
Figure 10.—Pacoima Lutheran Medical Center. Grouted brick wall at first floor, line E, from inside. Note diagonal crack in brick. Ralph Goers photograph.

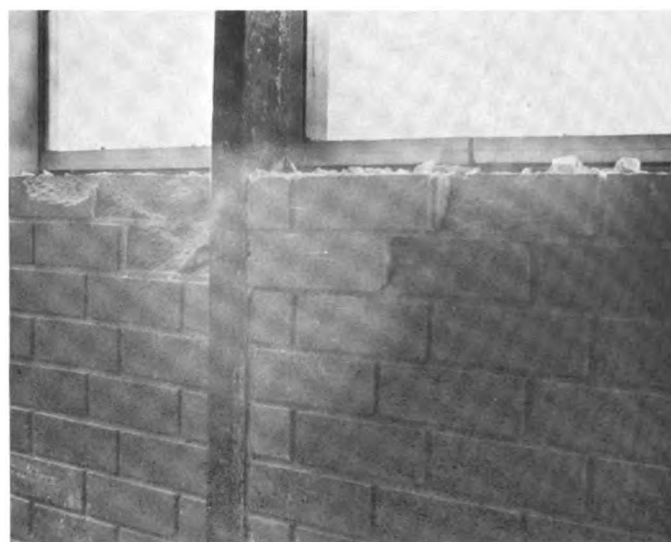
There were several areas of damage in the walls themselves. In addition to the previously discussed cracking at column E-1, there was some spalling of the brick at the top of the first-story sill wall owing to the cantilever action of the embedded steel tube columns (fig. 11).

Figure 11.—Pacoima Lutheran Medical Center. Grouted brick wall at first floor structural tube column. Note spalled concrete at top of wall. Ralph Goers photograph.

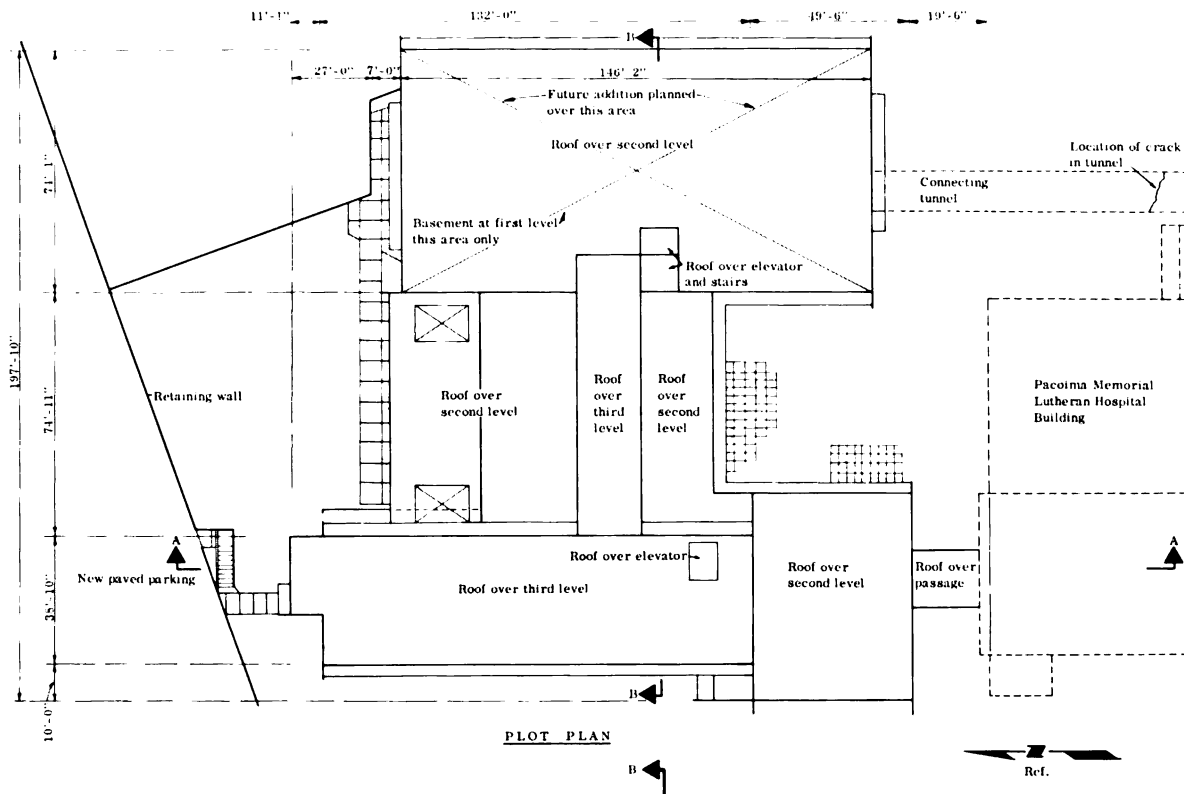
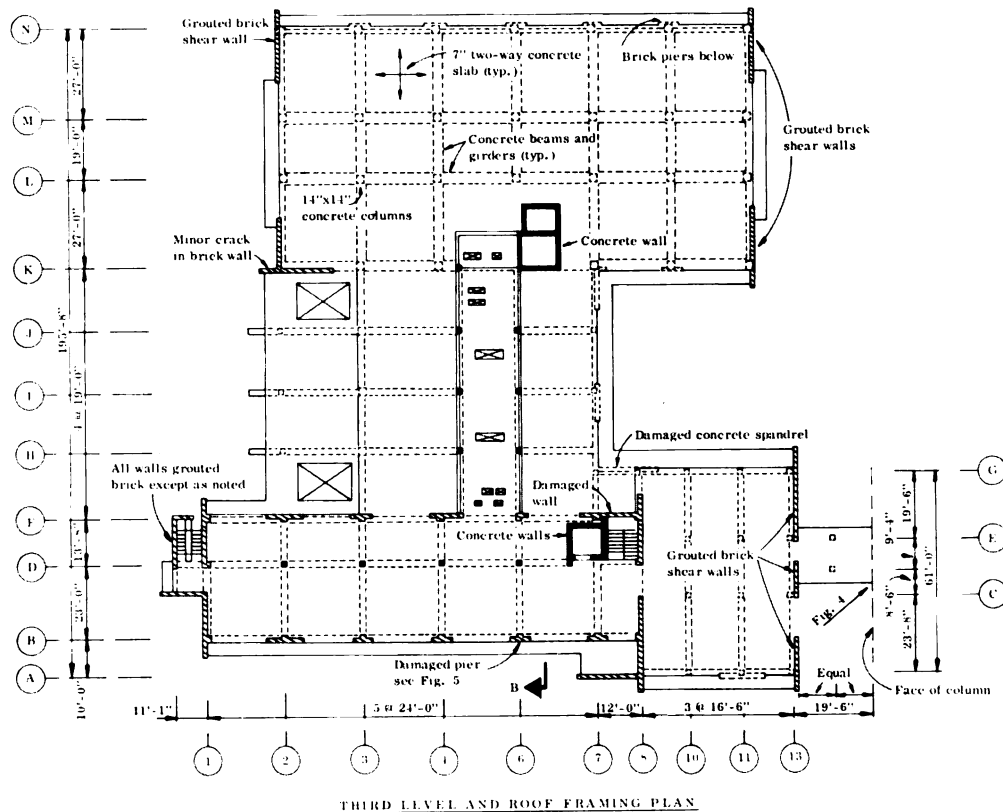
Figure 2.—Golden State Community Mental Health Center. Plot plan and third-level and roof framing plan.

The tunnel structure, which was not supported on piles, suffered a large crack through the roof and walls at the location shown in the plot plan (fig. 2). There was considerable differential movement within the tunnel. At the connection to the Mental Health Center, the tunnel had settled  $\frac{1}{2}$  inch, and from this point to the location of the crack there was a uniform slope down of  $1\frac{1}{2}$  inches. The tunnel connects to the hospital in two locations, where vertical offsets of  $1\frac{1}{2}$  and  $3\frac{1}{2}$  inches were observed. The filled area over the tunnel indicated that movement had occurred between the tunnel abutment and the

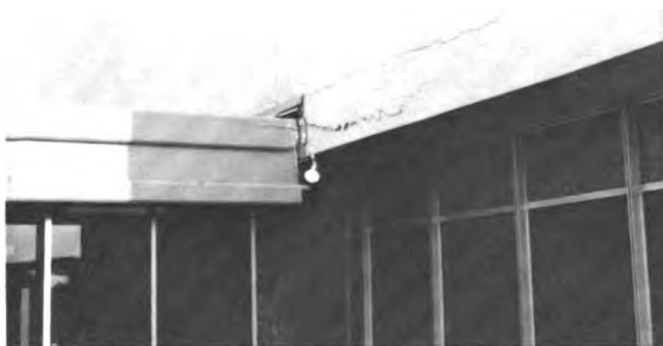
Figure 4.—Golden State Community Mental Health Center. Canopy roof over passage to main hospital. Vertical offset at joint is  $5\frac{1}{2}$  inches. Paul Fralessa photograph.

The most obvious damage occurred where the low roof over the passage abutted the main hospital building. Although there was no structural connection, the joint was flashed. Figure 4 shows a vertical offset of about  $5\frac{1}{2}$  inches, as well as some horizontal offset and evidence of pounding damage. The slab on grade immediately below also was offset vertically at the juncture of the two buildings. At line 13, where the canopy connects to the Mental Health Center, there was some minor spalling, but no evidence was found of flexural cracks in the canopy spandrels or slab.

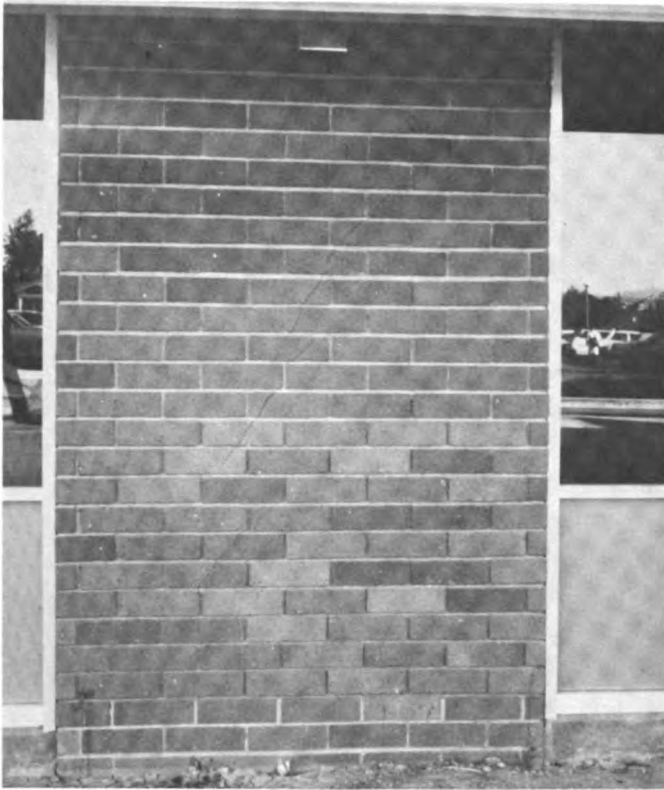
Figure 5 is a photograph of the first-story (above-grade) brick pier at column line 6 in the west wall (line B). It will be noticed that the diagonal cracks appear in one direction only. The second-story pier immediately above this one also was cracked in the same direction. South is to the right in this figure.

In order to verify the concept of differential soil compaction as a principal cause of the damage, a series of elevations was taken on the ground level on a north-south line near line D, running the length of the west wing of the building. Results indicated a relative vertical movement of over  $4\frac{1}{2}$  inches between lines 1 and 13, with line 13 being the low end. A definite change in the rate of slope occurred near line 7. The pattern of deformation along this line is consistent with the fact that the principal damage observed occurred in the walls near column lines 6 and 7. The direction of cracking in the pier at line 6 is also consistent with a relative settlement of the south end. Figure 2, section A-A, shows that the piles at the south end of the Mental Health Center do not reach the approximate plane of denser soils, and, further, the upper portions of the southernmost of those piles may be located in an area that was backfilled during construction of the hospital. It is probable that the piles at the south end of the west wing did settle with respect to the rest of the building, and that this action was the major cause of the damage observed.

Figure 5.—Golden State Community Mental Health Center. Cracked grouted brick wall on line B at line 6, looking east. Thomas Wosser photograph.

It is recommended that dynamic properties be considered in determining foundation criteria for an individual structure. In this building, it is probable that the differential structure settlement might have been eliminated or reduced by extending all piles to the same firmer strata under the structure.

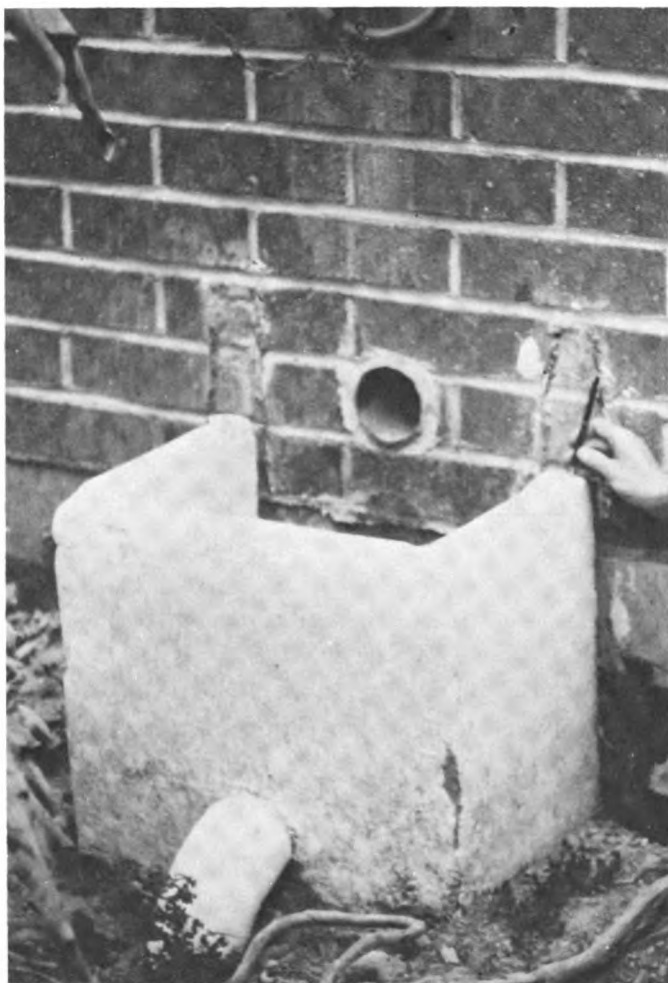
Figure 7.—Pacoima Memorial Lutheran Hospital. Vertical offset between catch basin and wall at brick wall 12 feet 11 inches west of line 7. Paul Fratessa photograph.

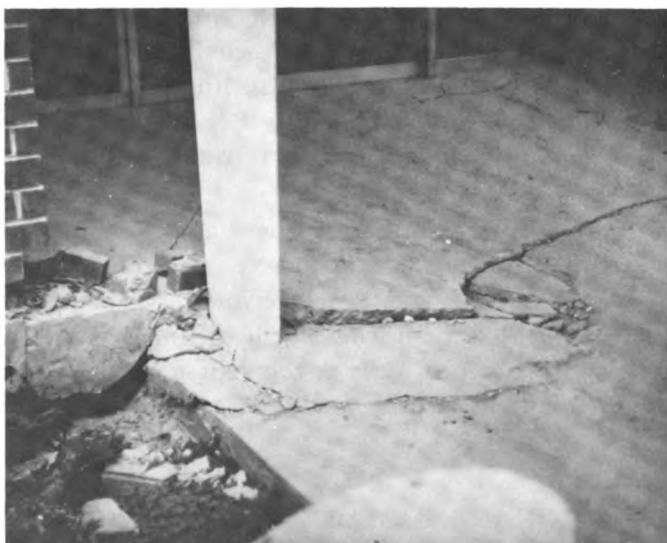
Figure 8.—Pacoima Memorial Lutheran Hospital. Slab on grade at main entrance. Paul Fratessa photograph.

The second level, where the main entrance is located, was damaged very severely. The floor slab at the entrance (near B-7) was cracked (fig. 8). The grouted brick shear wall between lines A and B, 12 feet 11 inches west of line 7, shattered along the base and moved about  $\frac{1}{2}$  inch to the south (fig. 19). The concrete wall north of the entrance (line B near line 7) suffered small diagonal cracks throughout. The concrete wall on line D at the west end of the unit was not damaged. The interior concrete block walls at the stairs and electrical closet near lines B and 7 were shattered badly. When these walls were removed, it was found that there were no dowels from slab to block wall as are customarily used. The concrete column at A-7 (fig. 20) and the adjoining two columns to the east were cracked. Evidently, this was due to north-south motion. The concrete at the column at C-7 was spalled badly. No damage was observed at other columns. The grouted brick shear wall 6 feet 1 inch east of line 15 was not damaged.

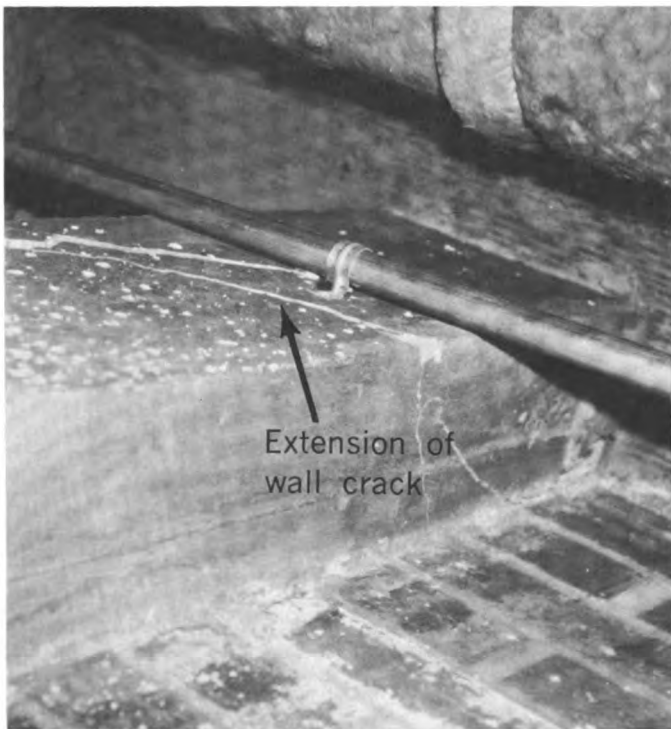
The only observed damage to this unit was the diagonal crack through the west brick wall (fig. 9). This crack extends through the concrete column, as shown in figure 10. There was evidence of pounding between the roof of this unit and the nursing wing second-level floor. Figure 11 shows the north end of the roof beam. The light substance at the expansion joint is Styrofoam joint material which has been forced out of the joint by compression. There was some damage to the flashing at the expansion joint. The concrete block walls and plaster partitions of this unit were virtually undamaged.

It is probable that the crack in the wall resulted from extra loads caused by the nursing unit pounding against the roof slab of the cafeteria unit.

Figure 10.—Pacoima Memorial Lutheran Hospital. Concrete column at brick wall on line 1x at line H. Crack through column is an extension of wall crack shown in figure 9. Loring A. Wyllie, Jr. photograph.

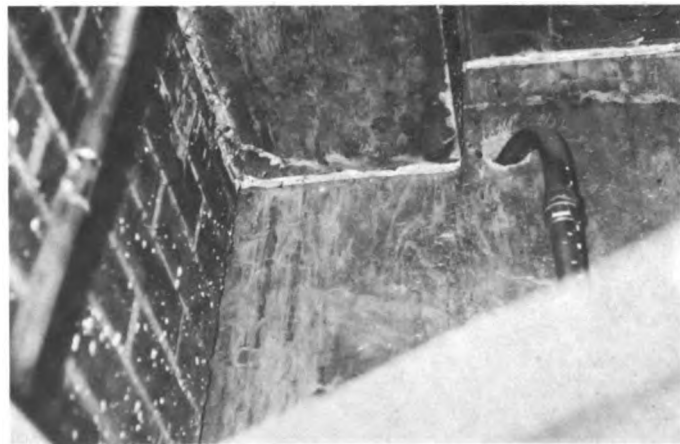
Figure 11.—Pacoima Memorial Lutheran Hospital. Joint at roof slab and beam soffit between cafeteria-mechanical unit and nursing hospital at line 1x. Loring A. Wyllie, Jr. photograph.

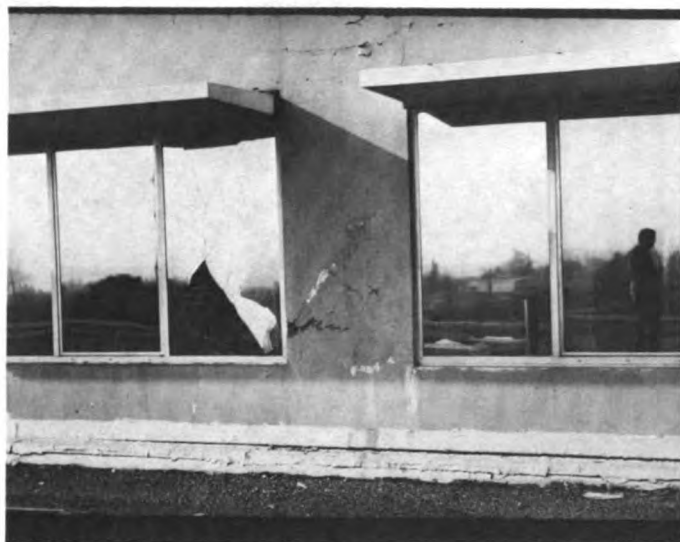
Figure 12.—Pacoima Memorial Lutheran Hospital. Pier on line G at line 10 looking north. Loring A. Wyllie, Jr. photograph.

The south wall suffered concrete cracking at the second-level column, just west of line 11 as shown in figure 12. Other than this, no significant cracks were observed in this wall. No cracking or damage was observed on the north wall (fig. 2) except for several broken windows.

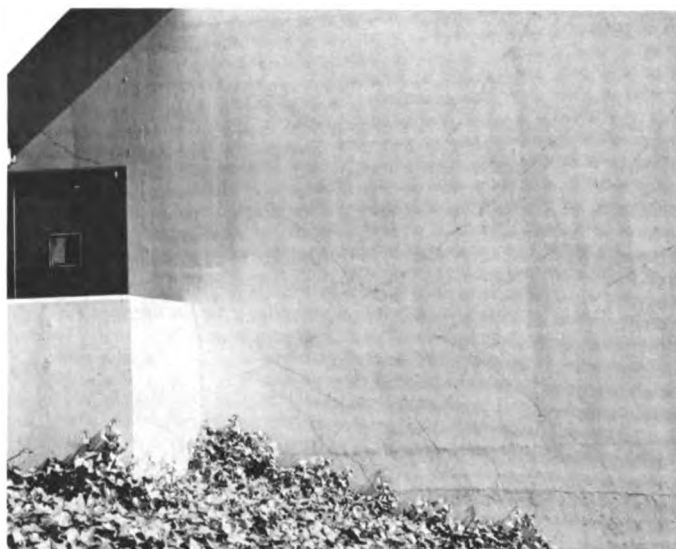
The west wall of this unit (fig. 4, line 1) had diagonal cracks in both directions in both piers at the

Figure 13.—Pacoima Memorial Lutheran Hospital. Shear wall at line 1, second level. Paul Fratessa photograph.

second level, but fewer similar cracks at the third level. Cracking was evident at the construction joints. The spandrel over the second-level door was cracked as shown in figure 15. Although it cannot be seen in figure 13, several of the diagonal cracks at the second level extend in a straight line through the third-floor construction joints and into the third-level wall. The wall below the second floor showed some diagonal cracks, which were smaller in number and size than those shown above the second floor.

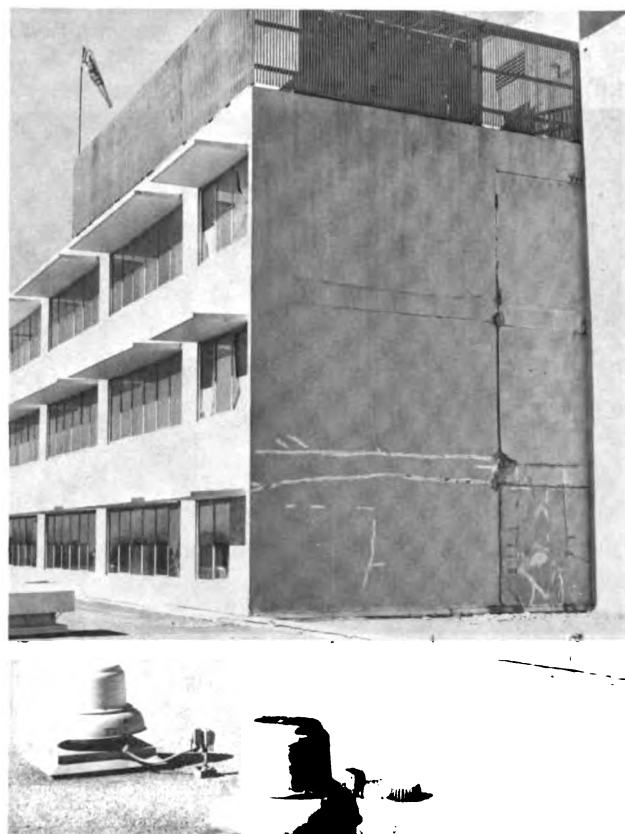
The shear wall at the second level and above on line 11 (fig. 5) was cracked severely as shown in figures 14 and 15. The diagonal cracks of the wall extend through the construction joints at the floors. All construction joints showed movement. The knockout panels for future construction showed movement. The white patches seen in figure 14 evidently were made before the earthquake. The thin piers adjacent to the stairwell and to the north of the knockout panel were shattered at the second level, as shown in

Figure 14.—Pacoima Memorial Lutheran Hospital. Elevation of shear wall on line 11. Patching of concrete prior to earthquake is visible. Note knockout panels at right side of wall. Paul Fratessa photograph.

The situation with the wall on line 11 is quite different. The building was designed for the future condition where all floor diaphragms would span from line 1 to line 17, with some support furnished at line 11 in accordance with its relative rigidity. Because of the many large wall openings, the wall on line 11 had a low rigidity, as compared to the walls on lines 1 and 17, and therefore would carry relatively small loads as shown in the (A) column (design forces) of wall line 11 in figure 5. In the condition that existed at the time of the earthquake, however, the future extension was not constructed, and there was no way to deliver loads to the wall on line 17. The full support of this portion of the building relied upon the strength of the wall on line 11. As shown at the wall on line 11 (fig. 5), the column (B) loads (code forces on wall as constructed) are substantially greater than column (A) loads above the second floor.

The damage pattern shown in photographs (figs. 14 and 15) clearly indicates this action, which is not specifically provided for in codes and was not anticipated in this structure.

- 2 In designing structures with future additions, the interim stress path must be examined more closely to determine the critical condition.

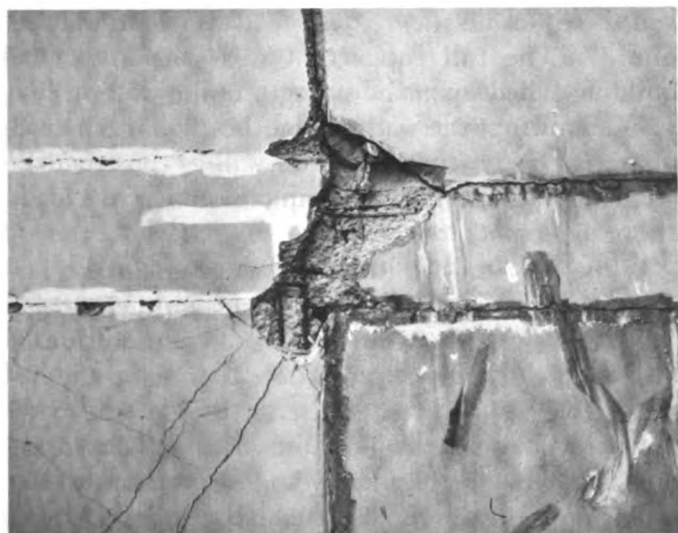
Figure 15.—Pacoima Memorial Lutheran Hospital. Closeup of damaged joint at knockout panel at third floor, line 11. Paul Fratessa photograph.

- 7 Additional stirrups and ties are needed at the ends of columns and girders where infill walls or knockout panels cause high shear stresses.

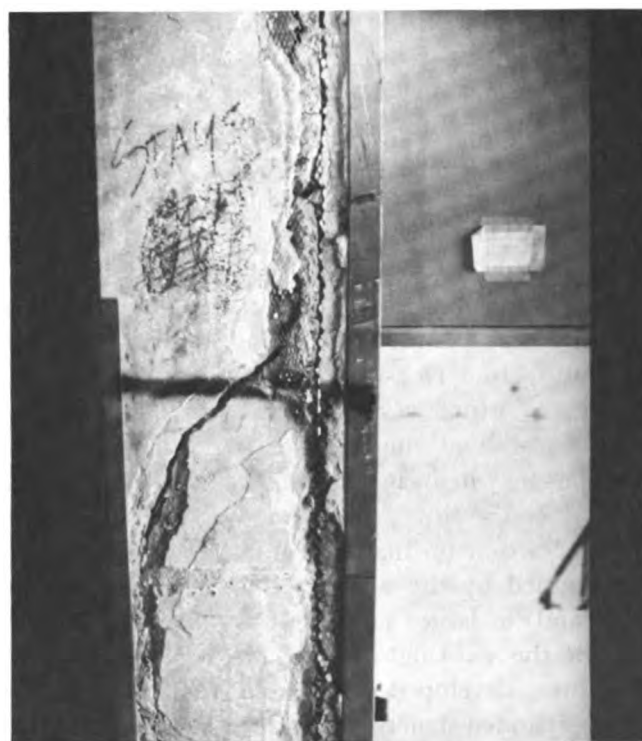
Figure 17.—Pacoima Memorial Lutheran Hospital. Thin pier on line 11 at second floor, adjacent to stair opening, looking east. Paul Fratessa photograph.
